15. Fall from Roof

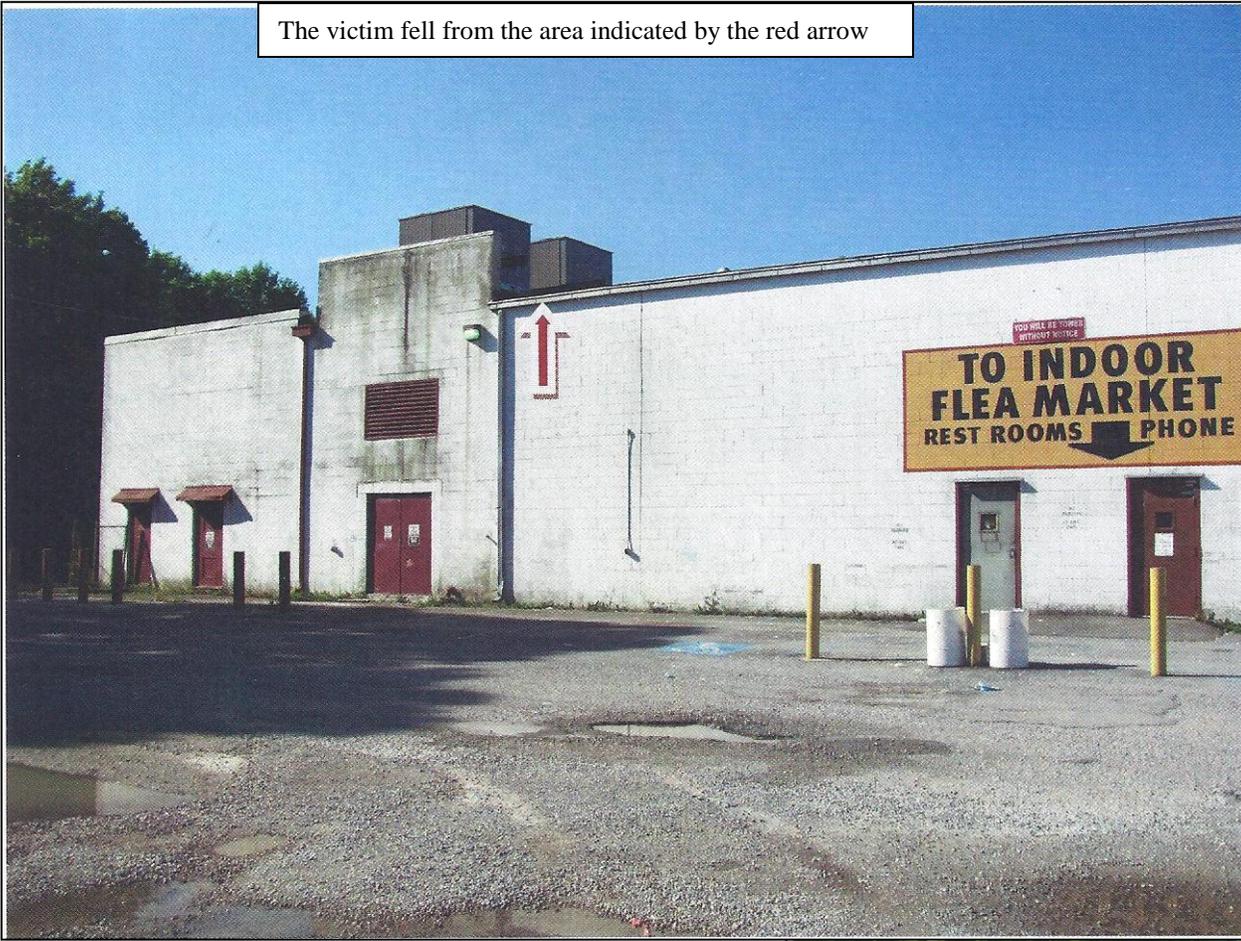
The victim fell from the area indicated by the red arrow

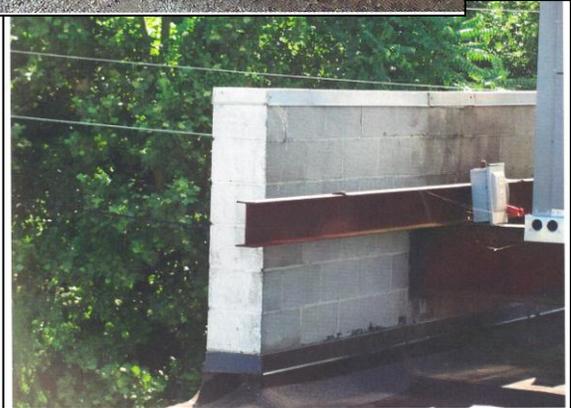
T.C.A. 50-3-105(1)	The employer did not furnish employment and a place of employment which were free from recognized hazards that were causing or likely to cause death or serious physical harm to employees in that the employer did not ensure that the proper rigging equipment was used to anchor the block pulley to the I-beam.

I-beam where the block and pulley was attached
